# Lion Air and Ethiopian Airlines Accidents

Tony Hays

Aircraft Design And Consulting

2022-11-22

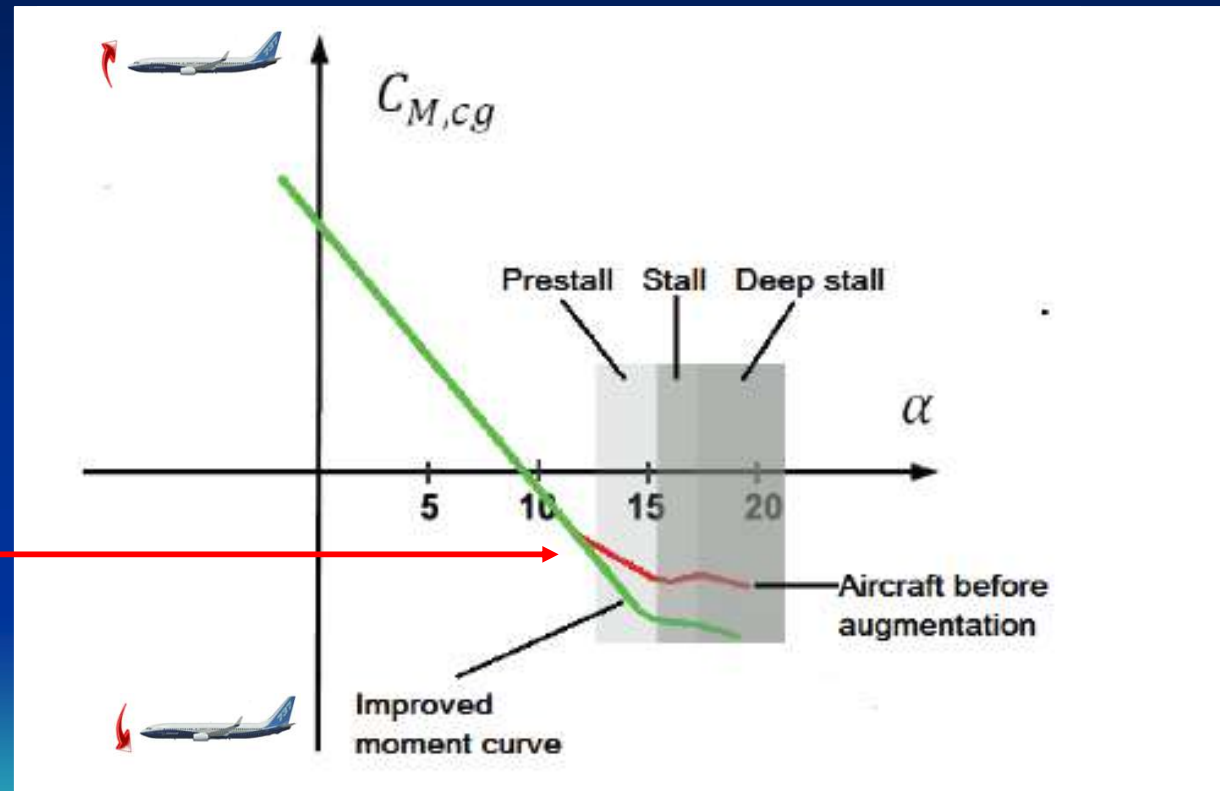
Close to stall ( $\alpha \sim 15^\circ$ ), nacelles generate enough lift to significantly reduce aircraft stability (red curve) at conditions

- flaps and slats retracted
- light weight
- aft c.g.

Without augmentation, pilots transitioning to MAX would have required sim. training

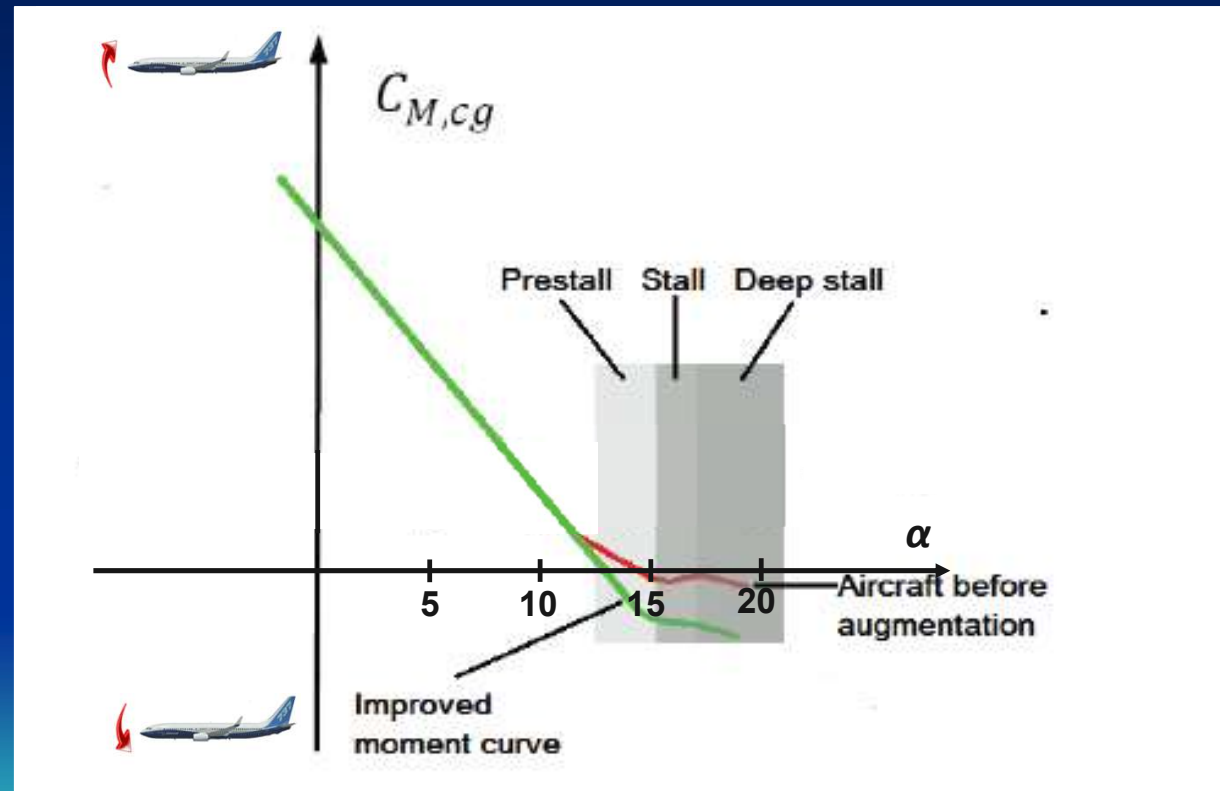
If trimmed close to stall ( $\alpha \sim 15^\circ$ ), airplane becomes neutrally stable

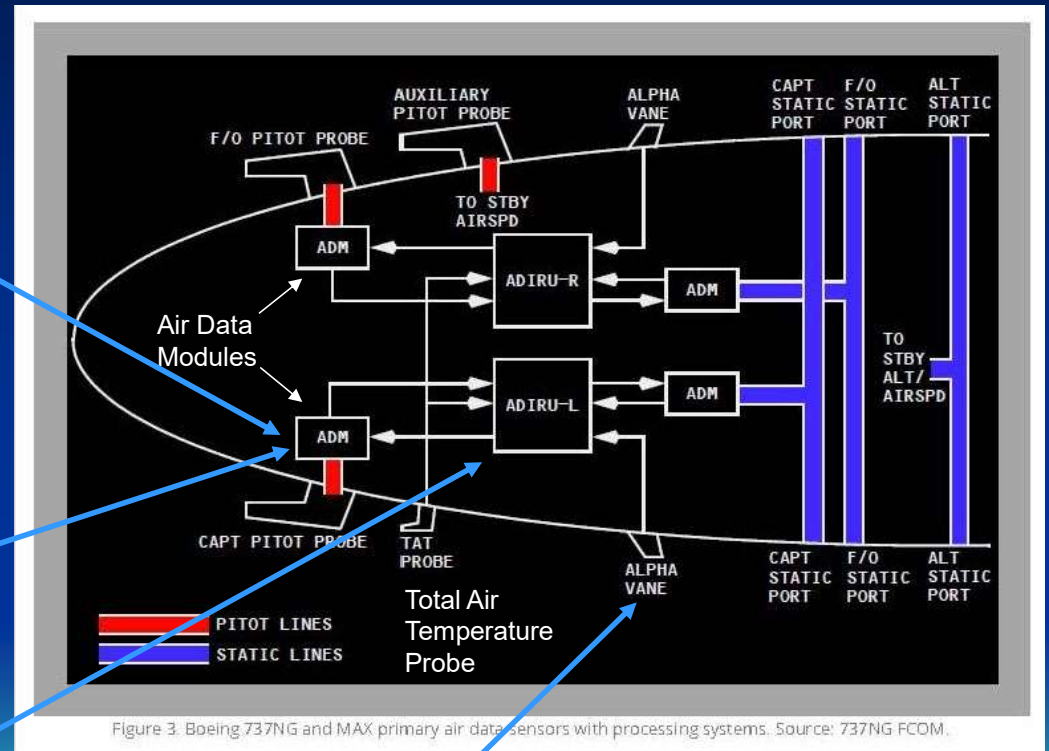
- For Lion Air flight JT610 (2018/10/29), on previous four flights captain's ASI had displayed unreliable values caused by incorrect AOA calculation
- Output from ADIRUs to Flight Control Computer and Elevator Feel Computer

MCAS took input from only one Alpha Vane

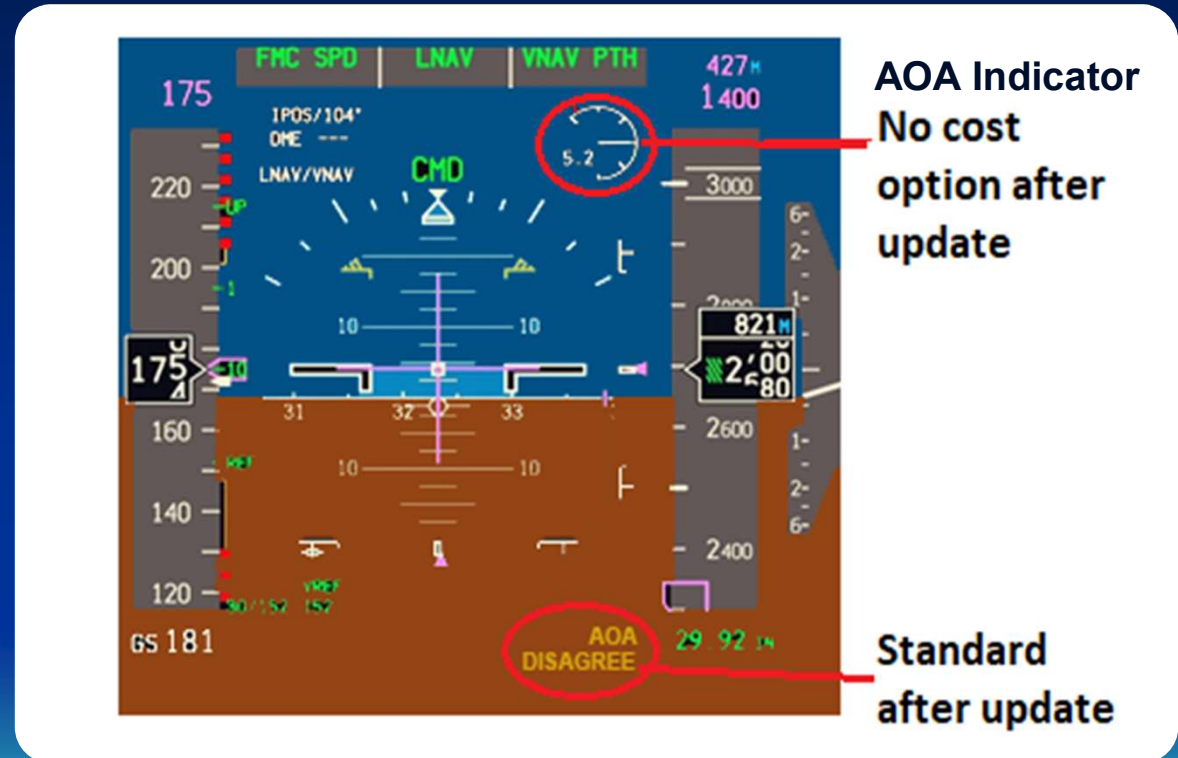
- If AOA sensors disagree by  $> 5.5^\circ$  with flaps retracted, MCAS will not activate
- If MCAS is activated in non-normal conditions, it will provide only one input for each elevated AOA event
- MCAS can never command more stabilizer input than can be counteracted by the flight crew using the control column

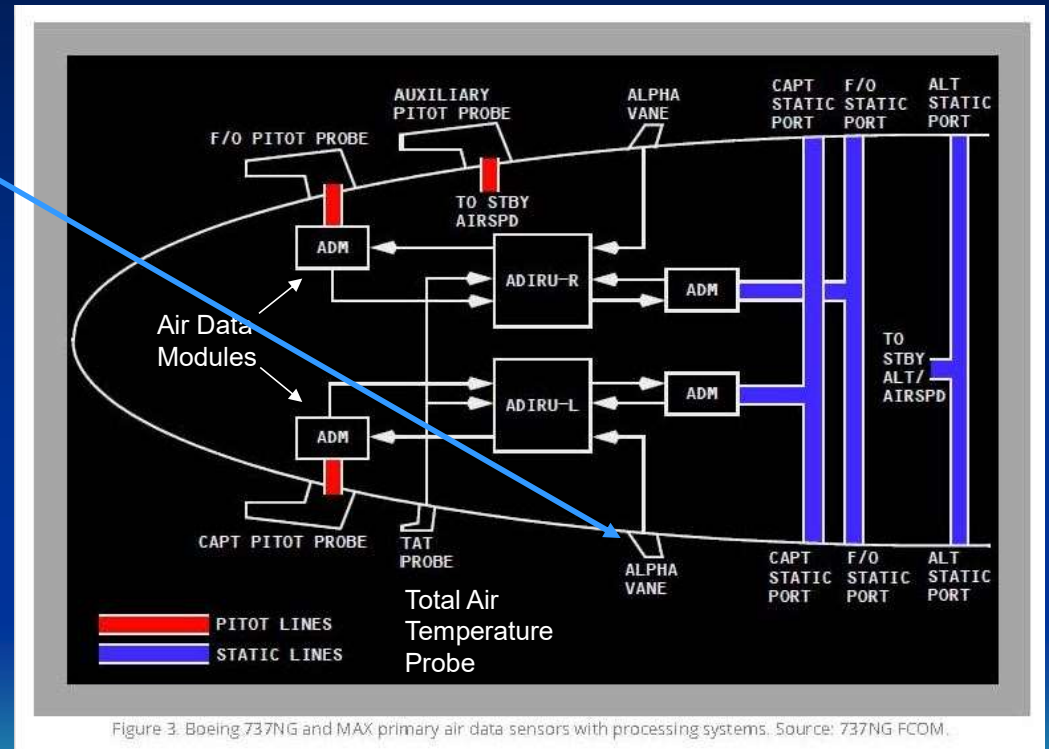
- For **Ethiopian Airlines** flight (2019-03-10), approx. 6 seconds after liftoff, captain's  $\alpha$  sensor showed very high value
- Vane probably sheared off by bird impact
- Stick shaker active
- MCAS activated, then manually turned off
- Crew tried to trim manually using console trim wheel, but could not
- Cut-out switches turned back on, re-activating MCAS
- During brief -ve g,  $\alpha$  sensor shows low value
- Crew probably overwhelmed by high workload

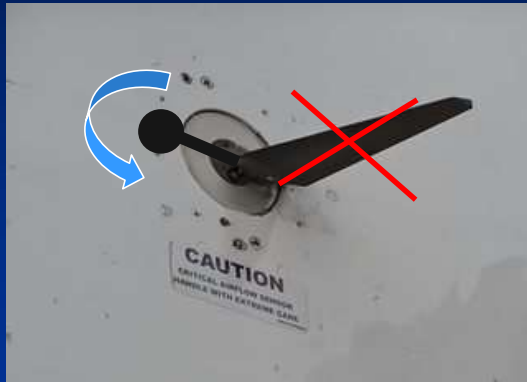
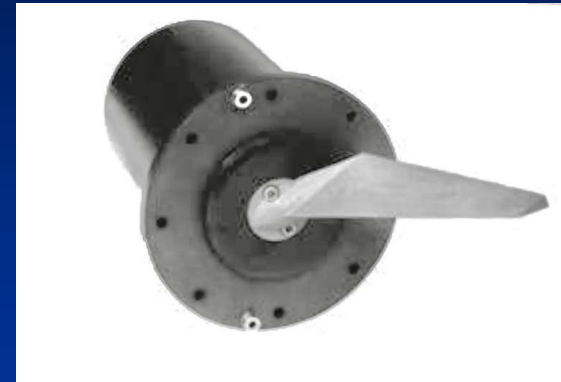
If vane is broken off

Internal counter-balance rotates shaft  
to indicate high value of  $\alpha$

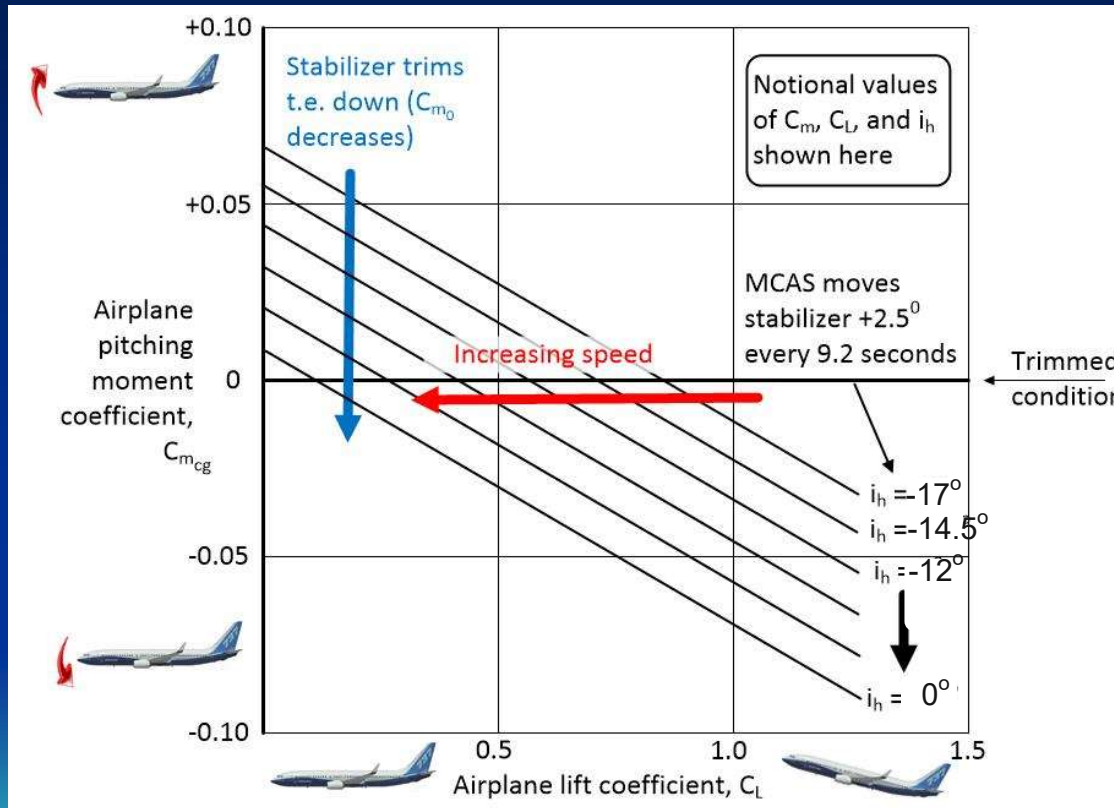
MCAS rates shown at time of accidents (now reduced to just one movement of stabilizer)

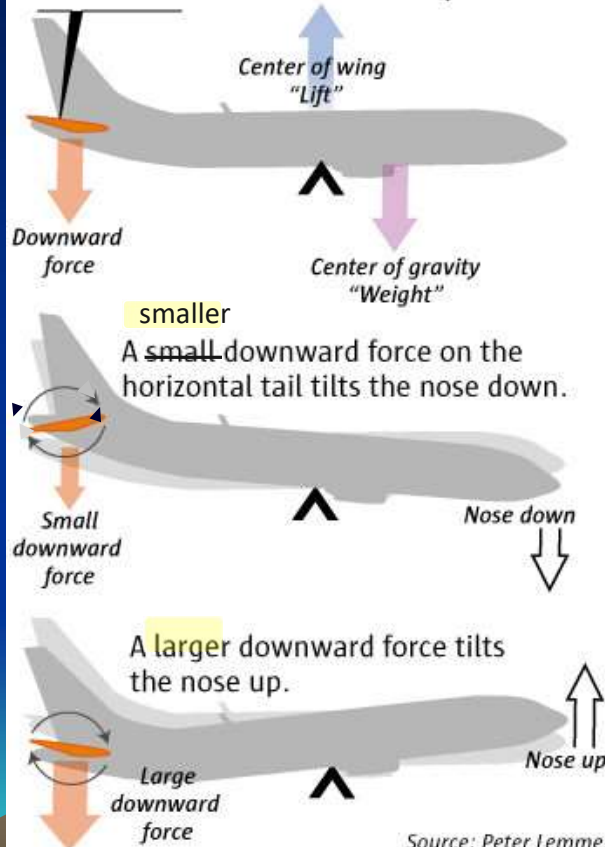
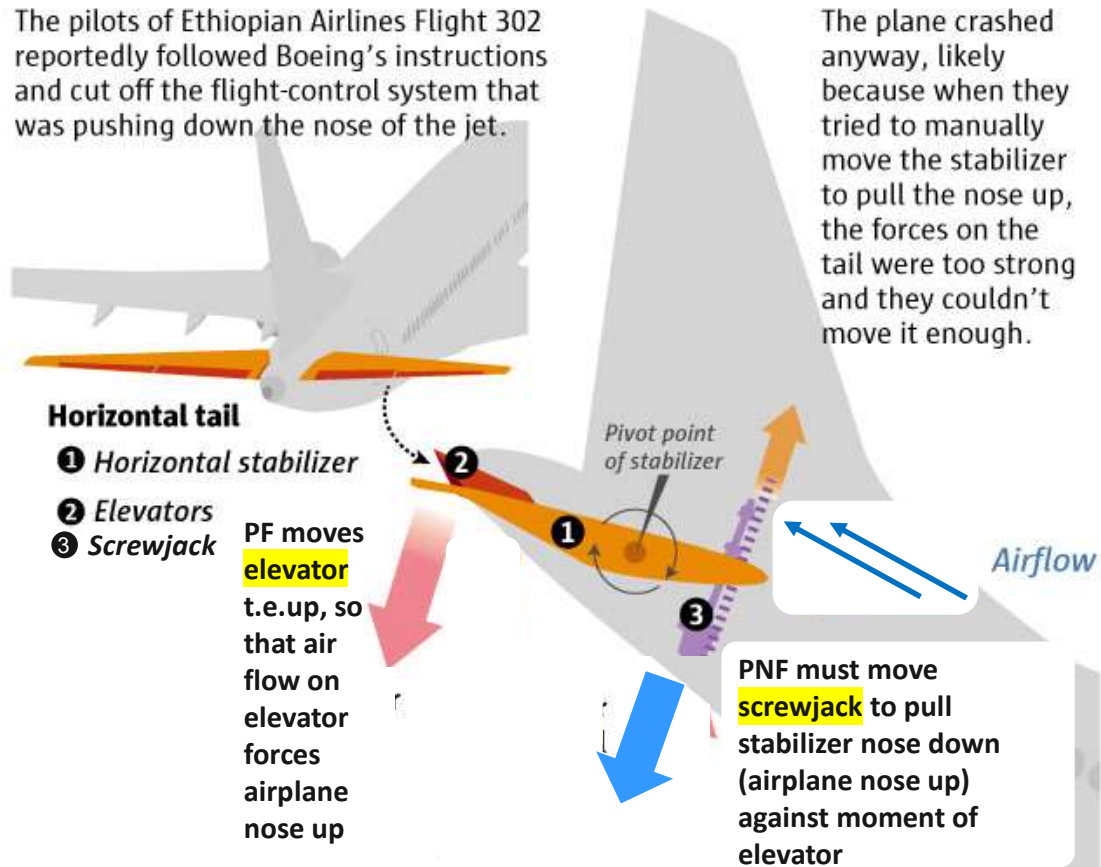
# With the 737 MAX's automatic system cut off, forces on the horizontal tail could make it very difficult for pilots to swivel it manually

The horizontal tail always exerts a downward force to balance the plane.

The pilots of Ethiopian Airlines Flight 302 reportedly followed Boeing's instructions and cut off the flight-control system that was pushing down the nose of the jet.

The plane crashed anyway, likely because when they tried to manually move the stabilizer to pull the nose up, the forces on the tail were too strong and they couldn't move it enough.
