# Lion Air and Ethiopian Airlines Accidents

Tony Hays

Aircraft Design And Consulting

2022-11-22

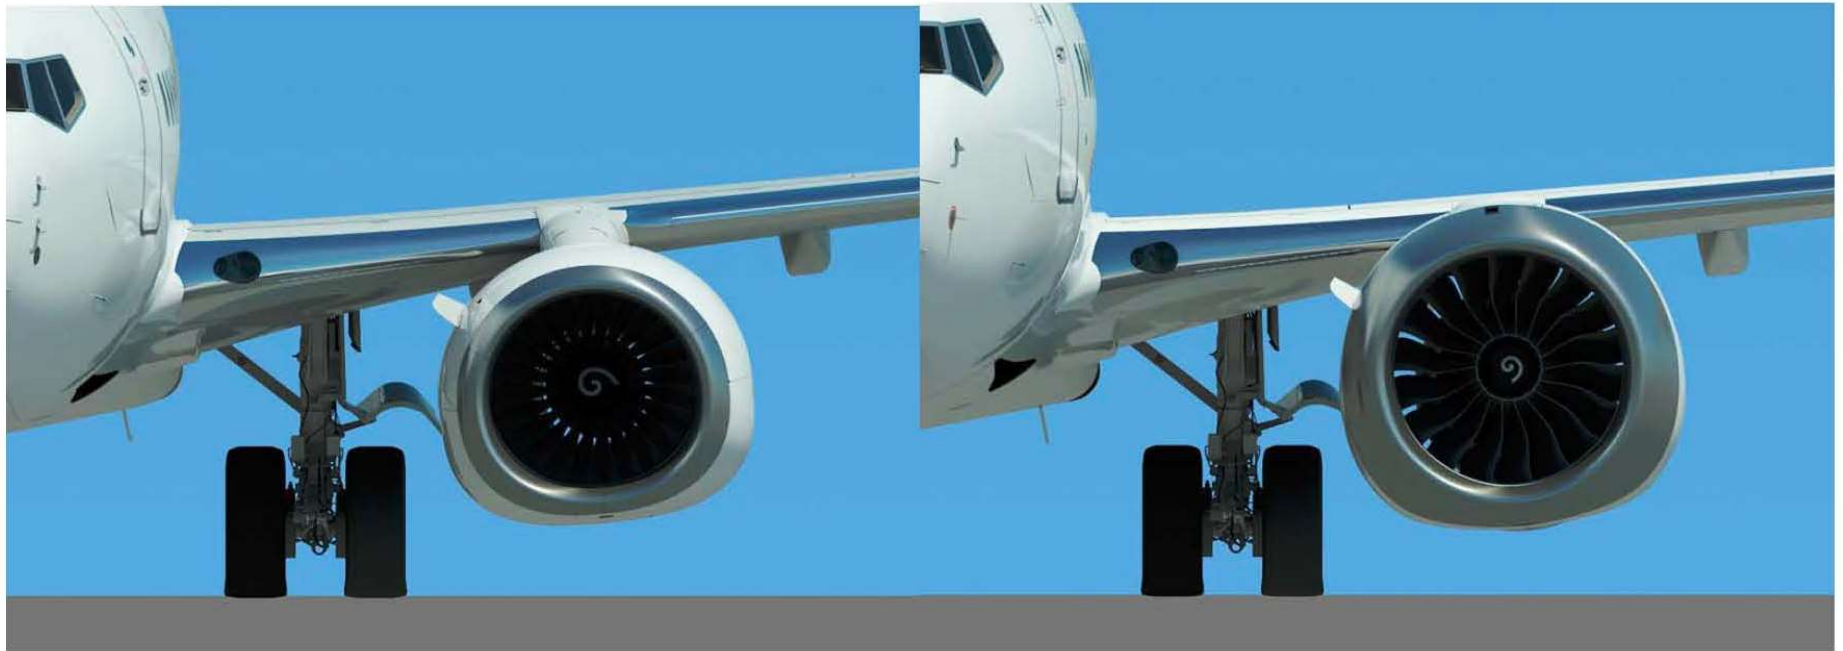
Figure 1. Boeing 737NG (left) and MAX (right) nacelles compared. Source: Boeing 737 MAX brochure.

- LEAP-1B engines
- Increased nacelle x/s area decreased longitudinal stability

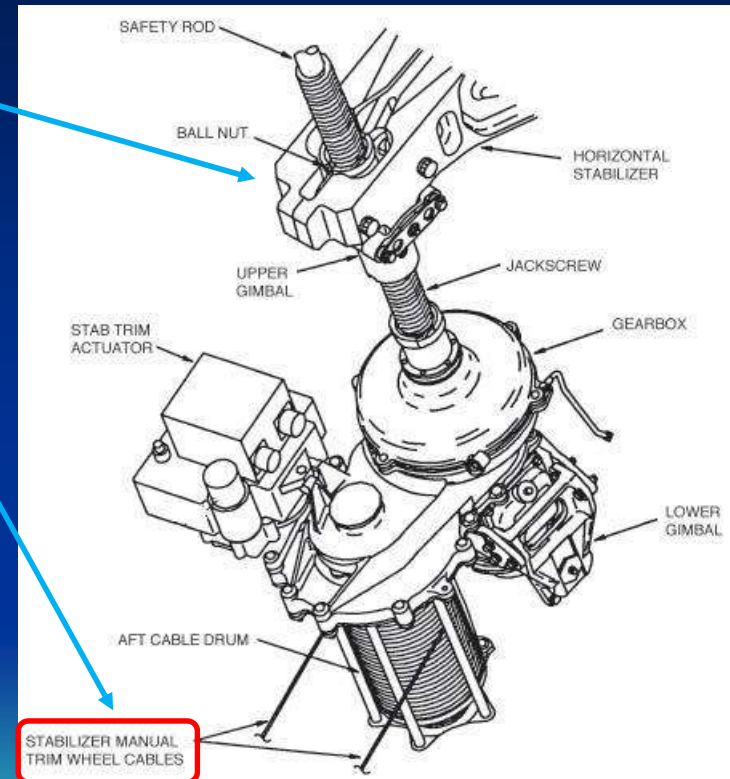
Attached to front spar of  
**horizontal stabilizer**

Manual trim is slow (250 rotations to cover 17°, i.e. full range of travel) and requires much effort. Electric trim is 2x faster and MCAS is 4x faster

If pilot is pulling yoke nose up, then manually moving stabilizer trim nose down is almost impossible

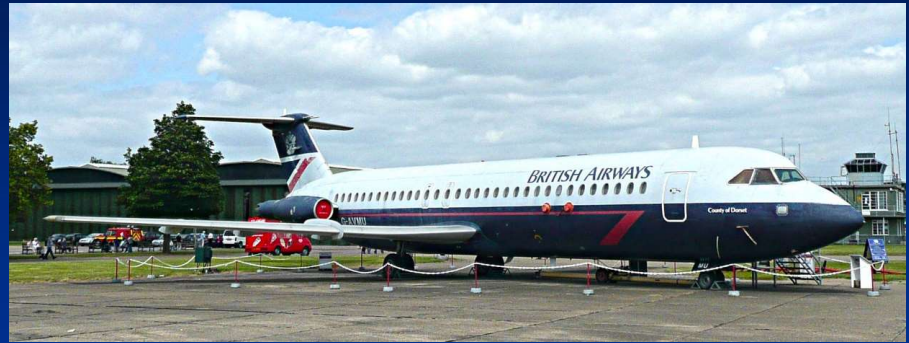
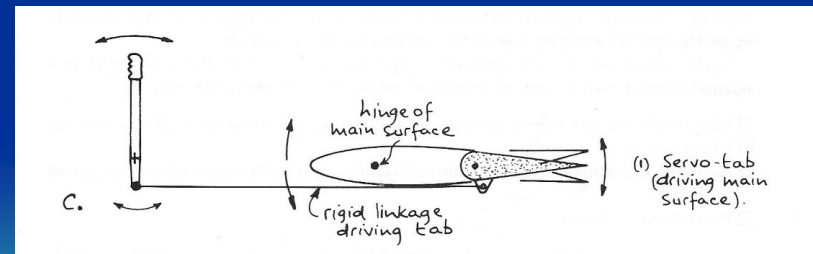
Source: Stinton, The Design of the Aeroplane, Fig. 12.7

- 1963-10-22
- Pilot: Mike Lithgow plus 6 flight test crew
- Aft c.g.
- Entered stall at 16,000 ft
- Hit ground a low forward speed
- Exacerbated by servo-tab-operated elevator

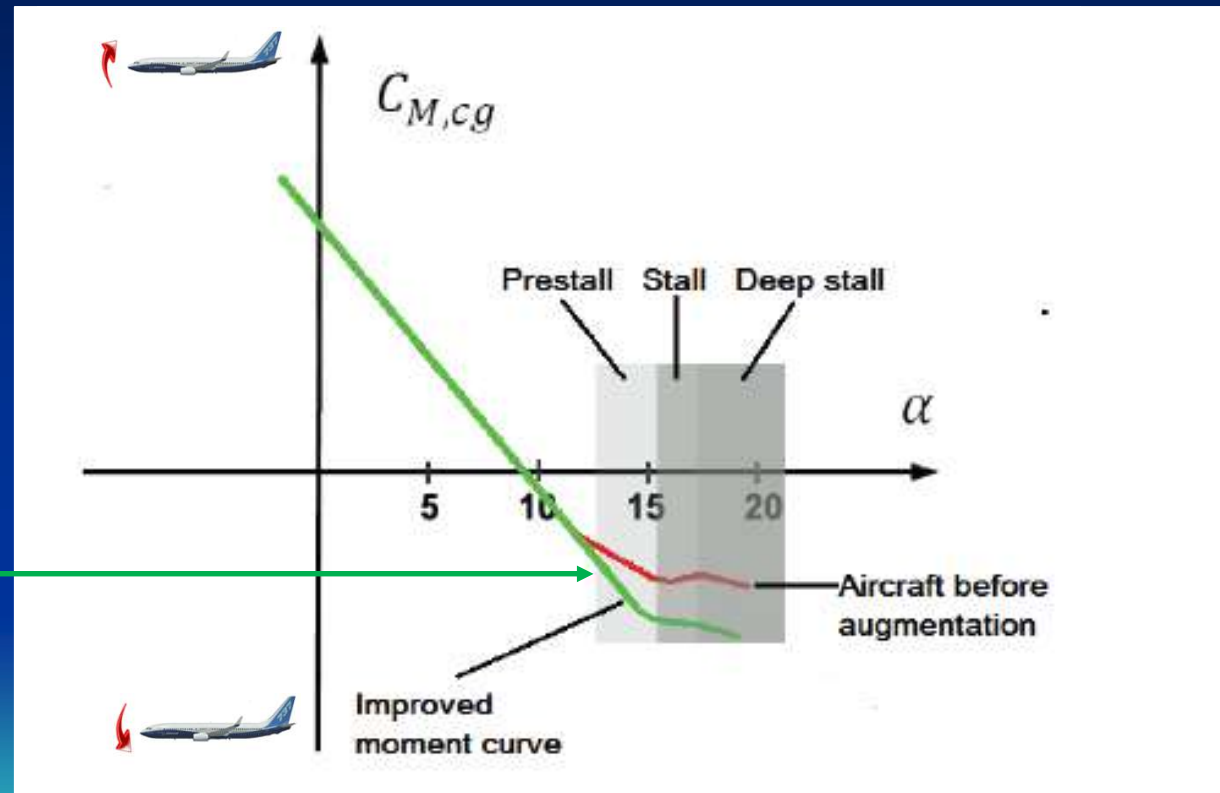
Close to stall ( $\alpha \sim 13^\circ$ ), nacelles generate enough lift to reduce aircraft stability

MCAS (Maneuvering Characteristics Augmentation System) actuates auto-trim that simulates linear  $dC_m/d\alpha$  up to  $\alpha \sim 15^\circ$

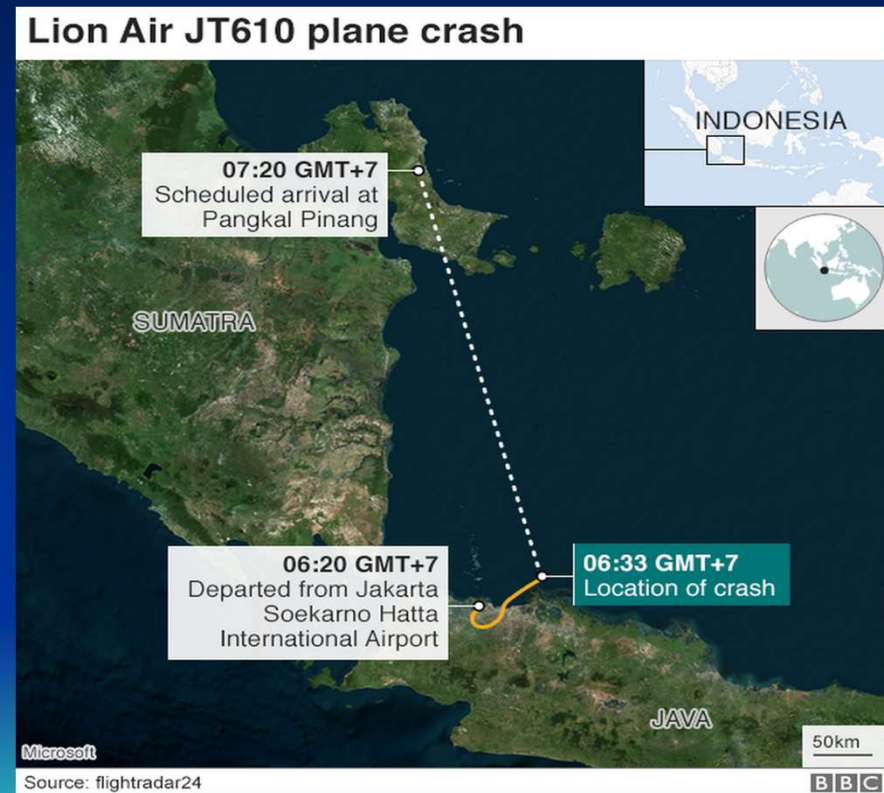
Prior flights:

Tianjin – Manado

Manado – Denpasar

Denpasar - Jakarta

“On 26 October 2018, the SPD (speed) and ALT (altimeter) flags on the Captain’s primary flight display first occurred on the flight from Tianjin, China to Manado, Indonesia.

Following reoccurrence of these problems, the left angle of attack (AOA) sensor was replaced in Denpasar on 28 October 2018.”
